Assessments of House Damage from Event Dial Pack and 100 ton AN/FO Test

Interim Report

Prepared by: C. Wilton, URS Research Company

DEFENSE NUCLEAR AGENCY
WASHINGTON, D.C.

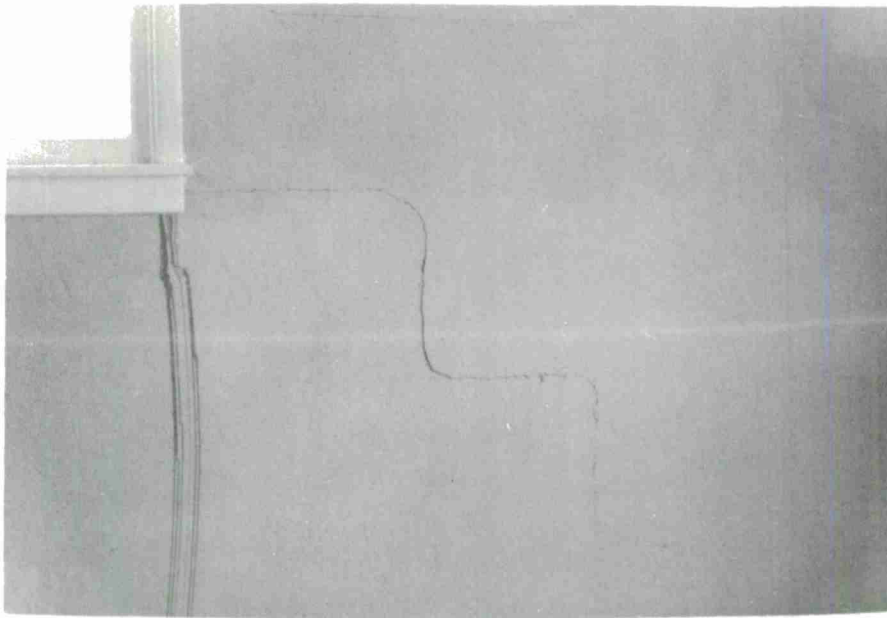
Minor plaster cracks were noted throughout the house. Especially numerous were those around the windows and over the doorways. Examples of these are shown in Appendix A, Figures A-1 and A-2. More severe plaster cracks were found in the front wall of the house near the bottom corner of the windows. See Figures A-3 and A-4 (photographs of the lower left corner of the front windows of the north and south bedrooms). Upon removal of small sections of the plaster and sheetrock in these areas, it was found that the vertical studs (2 by 4's) were cracked at this point (see Figures A-5 and A-6). No further unrepaired damage was noted.

Fig. A-1. Pretest Plaster Cracks, Kitchen North Wall (vertical marks are water stains, not cracks)

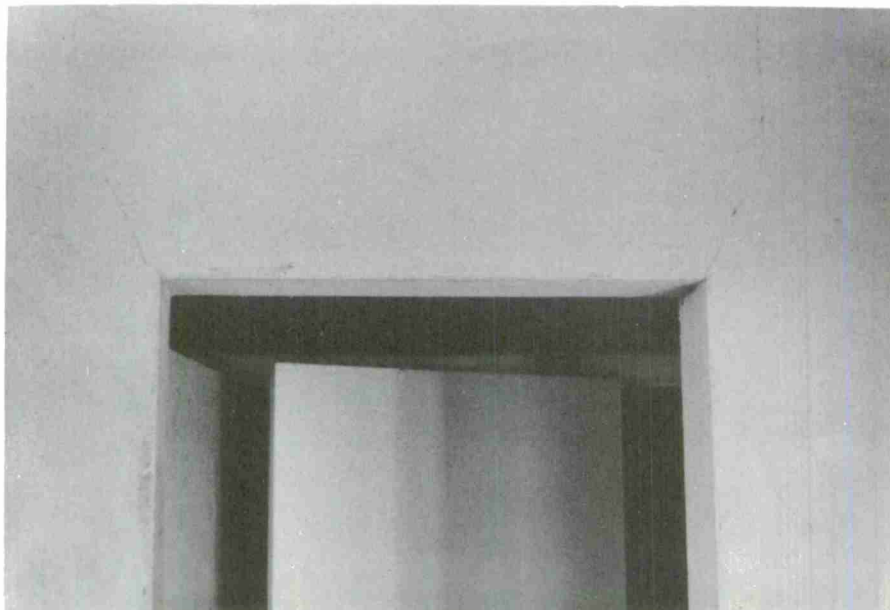
Fig. A-2. Pretest Plaster Cracks, Kitchen Door

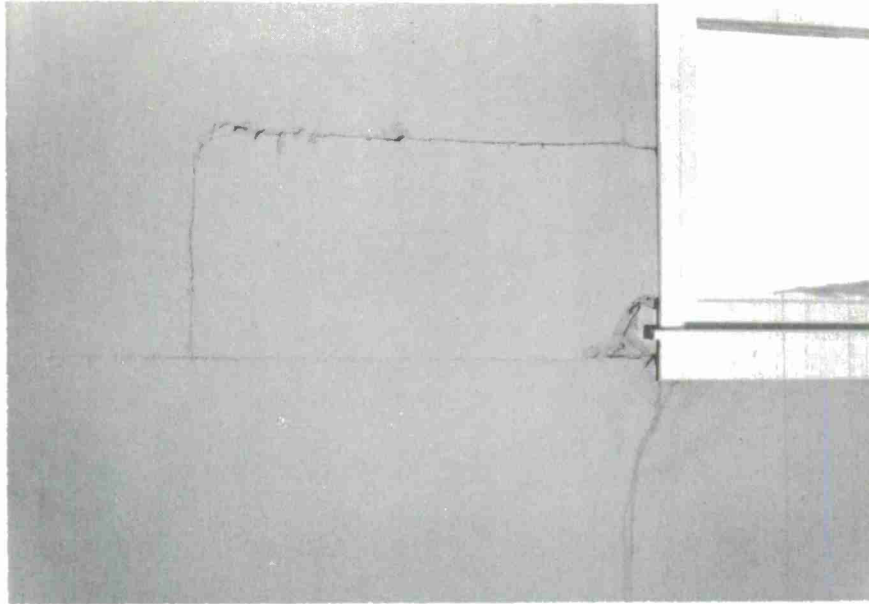
Fig. A-3. Pretest Plaster Cracks, South Bedroom, Front Window

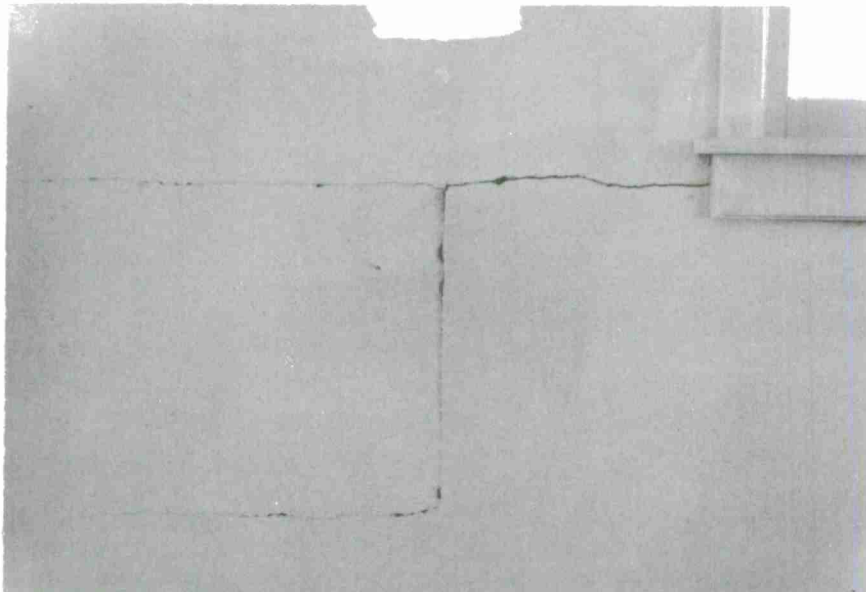
Fig. A-4. Pretest Plaster Cracks, North Bedroom, Front Window

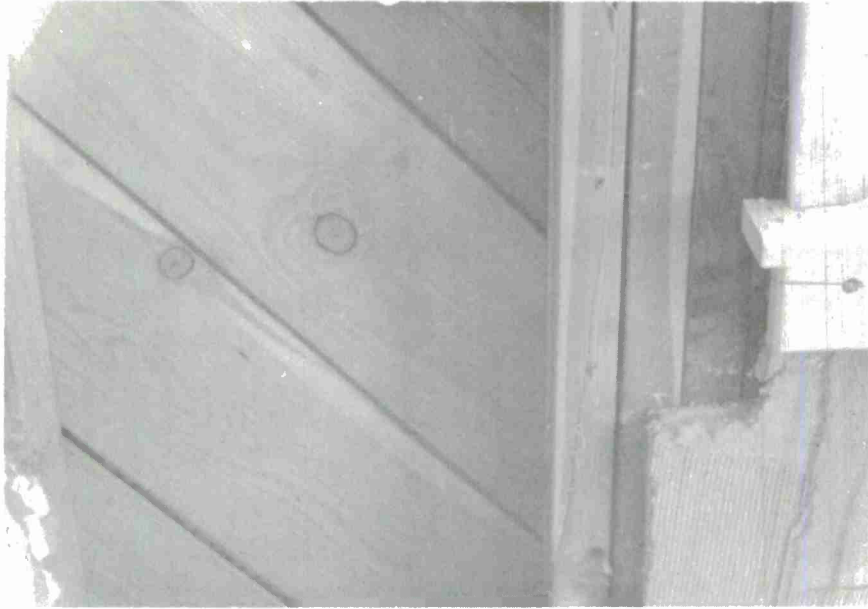
Fig. A-5. Pretest Close-up of Cracked 2 by 4, North Bedroom, Front Window

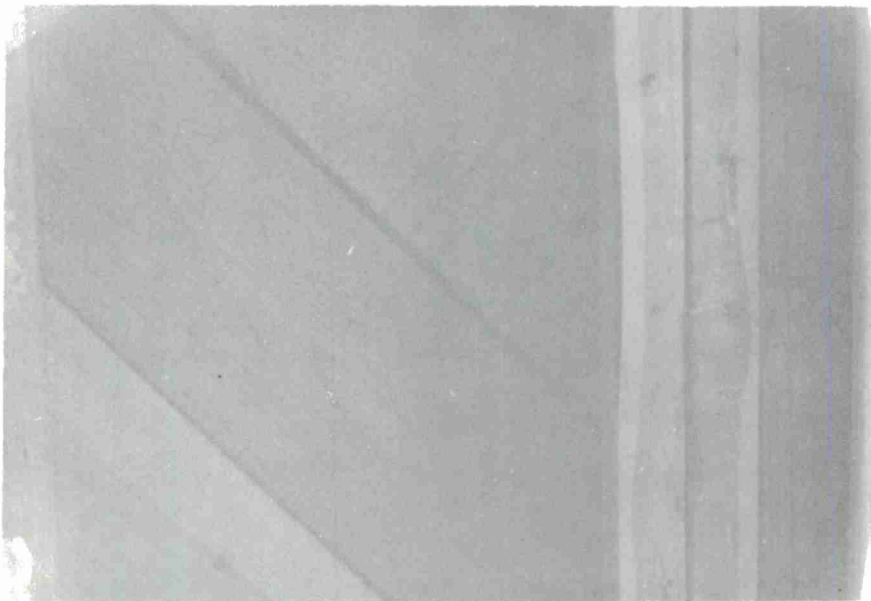
Fig. A-6. Pretest Close-up of Cracked 2 by 4, South Bedroom, Front Window

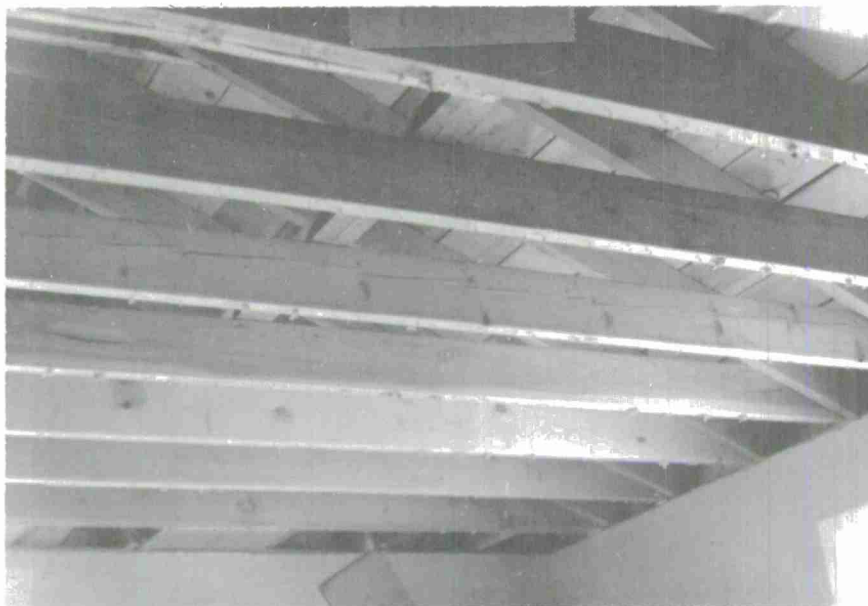
Fig. A-7. Posttest Ceiling Damage, Upstairs Rear North Bedroom

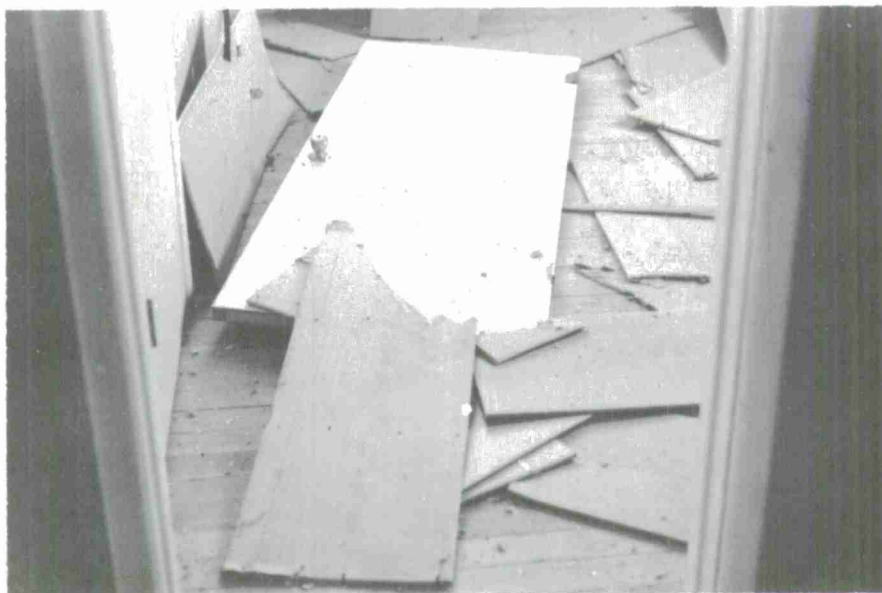
Fig. A-8. Posttest Door and Ceiling Sheathing on Floor of Upstairs Rear North Bedroom

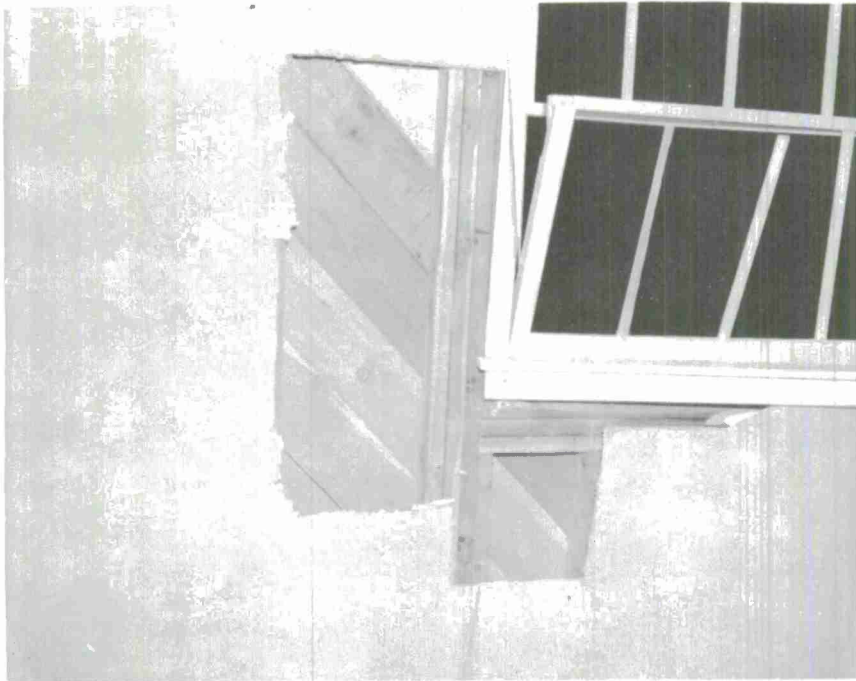
Fig. A-9. Posttest Upstairs Front Bedroom, North Side

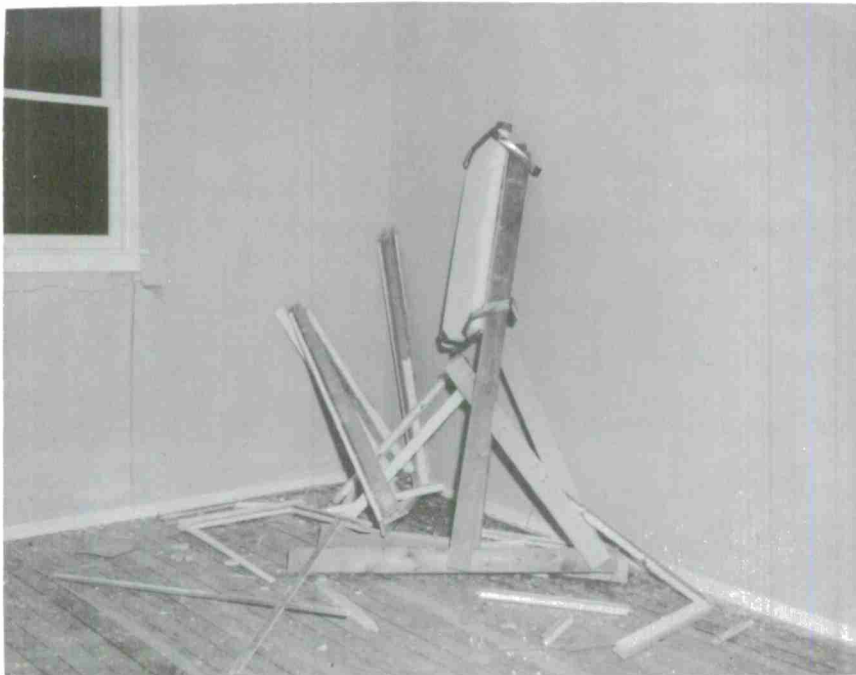
Fig. A-10. Posttest Northwest Corner, Master Bedroom, Showing Window From South Wall and Glass Trap

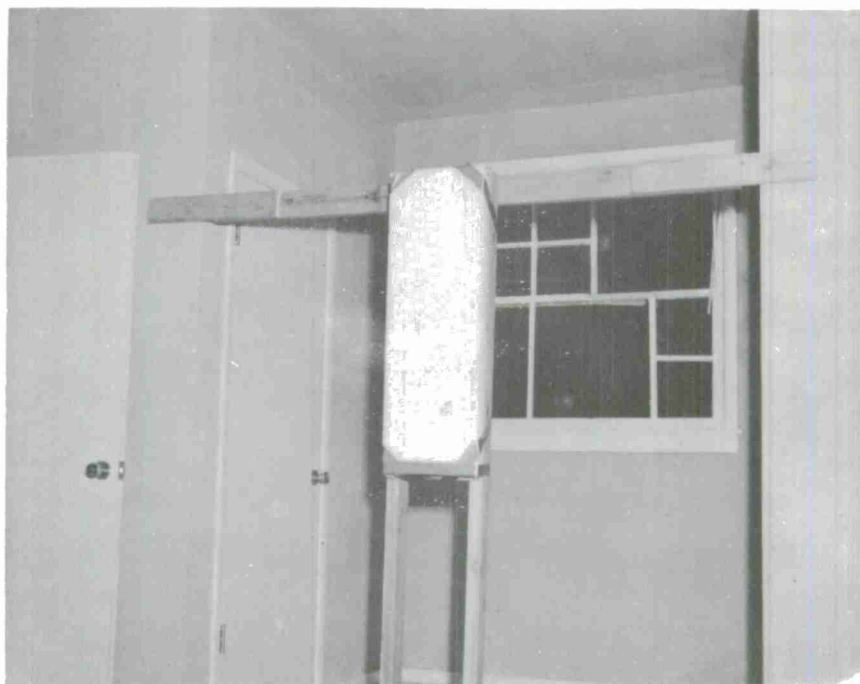
Fig. A-11. Posttest East Wall, Master Bedroom

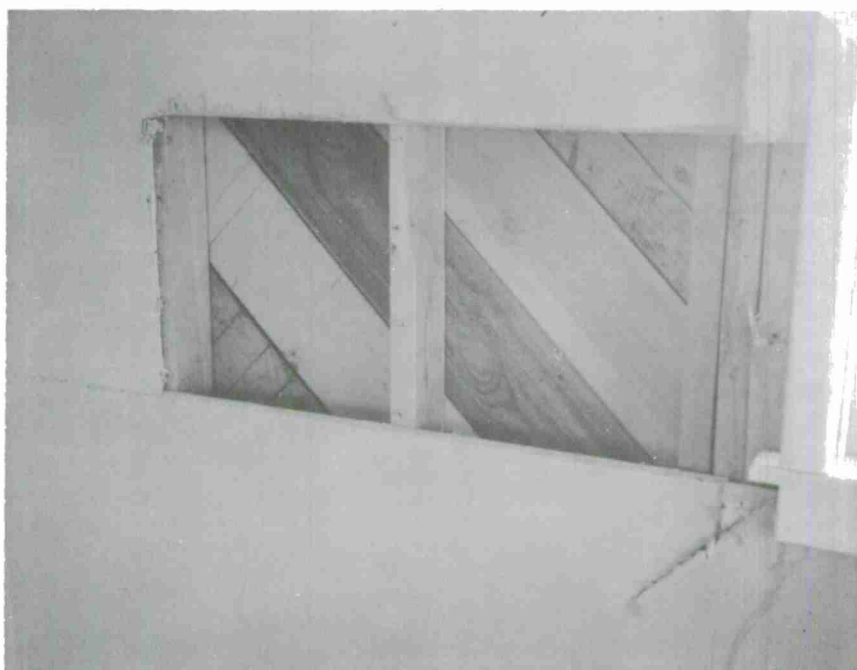
Fig. A-12. Posttest Dining Room, West Wall

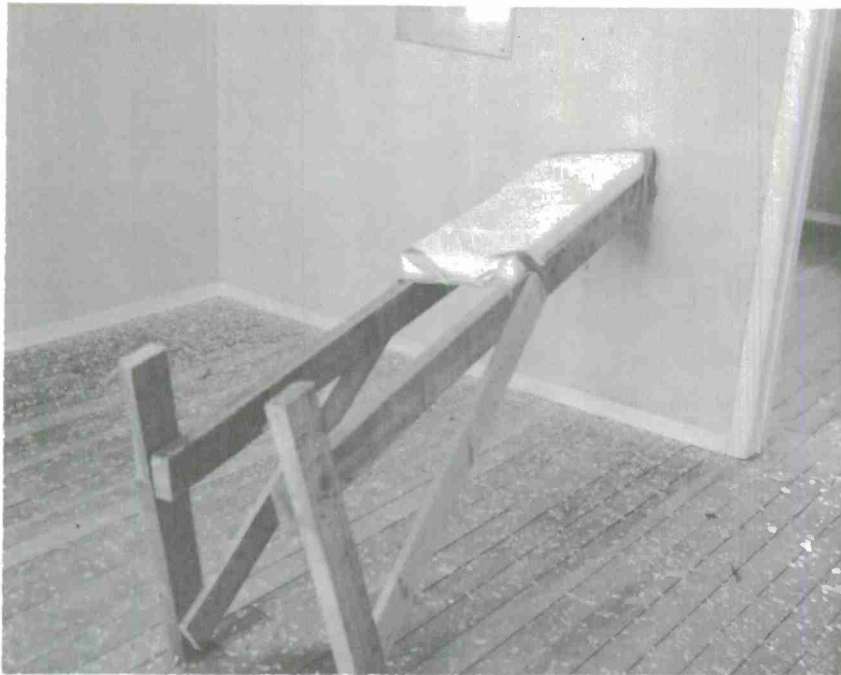
Fig. A-13. Dining Room East Wall, Showing Damaged Glass Trap

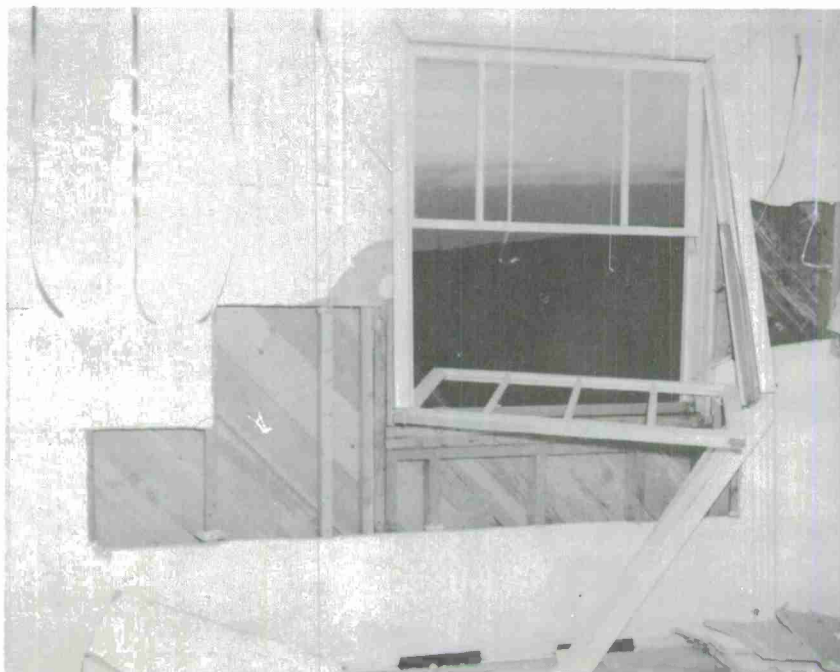
Fig. A-14. Living Room, West Wall

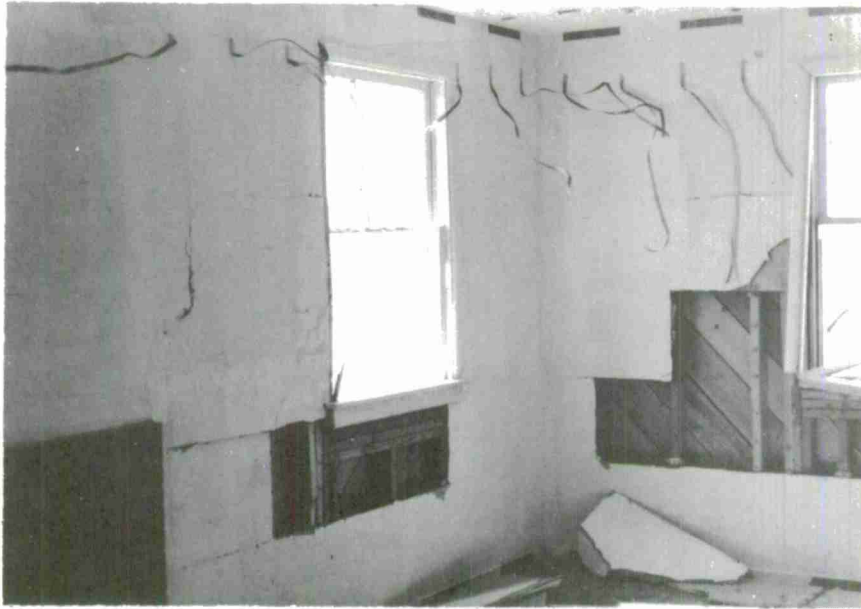
Fig. A-15. Posttest Living Room, Southwest Corner

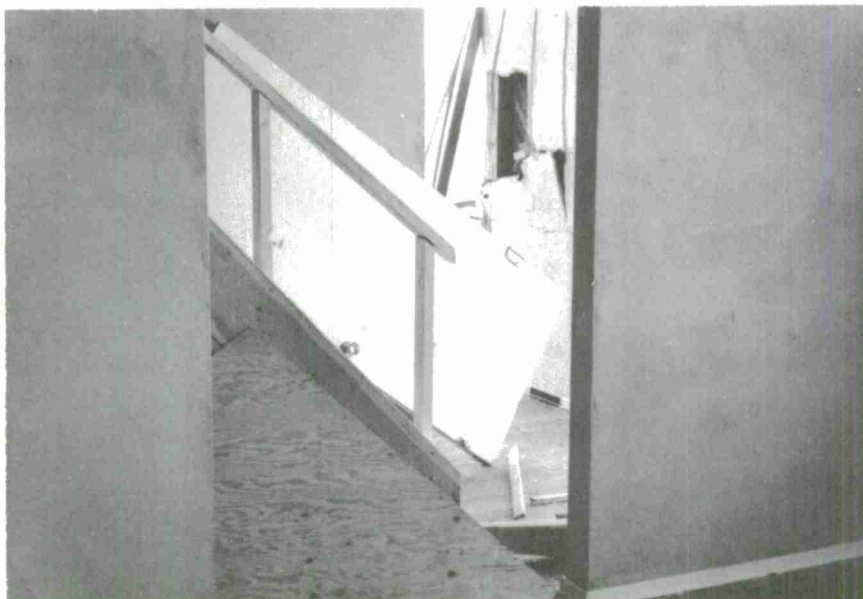
Fig. A-16. Posttest View from Dining Room into Hall
Showing Location of Door

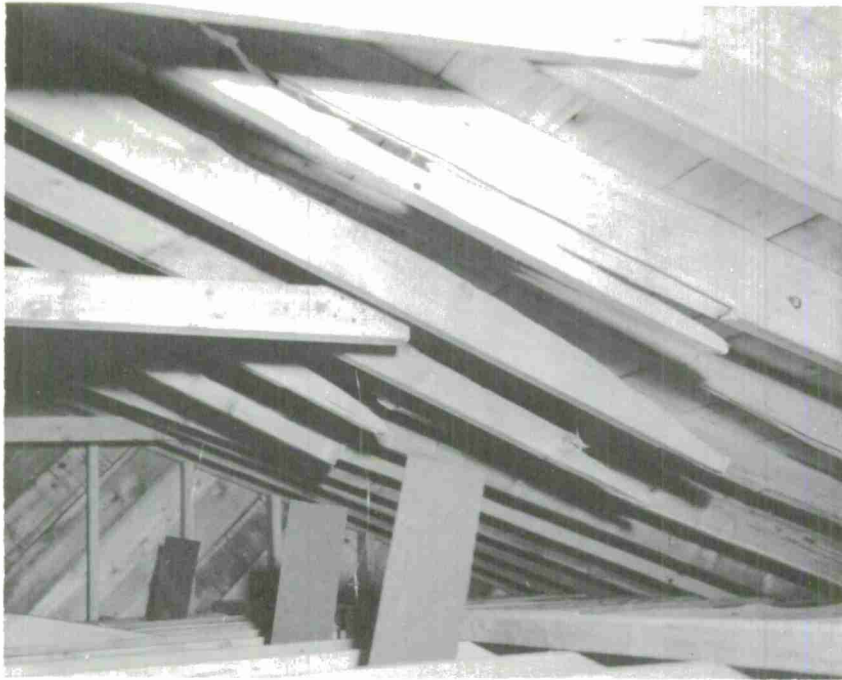
Fig. A-17. Posttest Attic, Westside, View Looking North

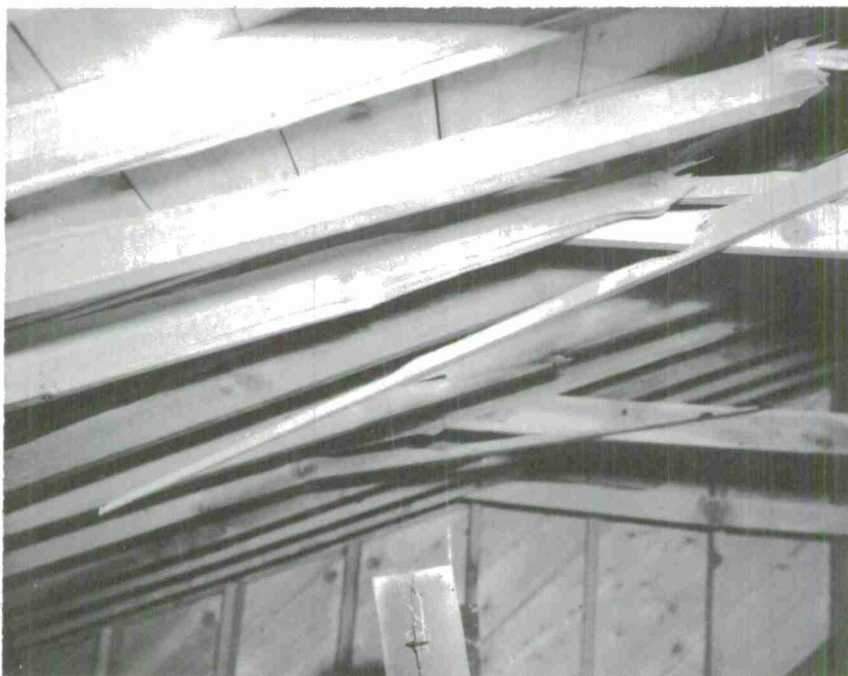
Fig. A-18. Posttest Attic, Westside, View Looking South

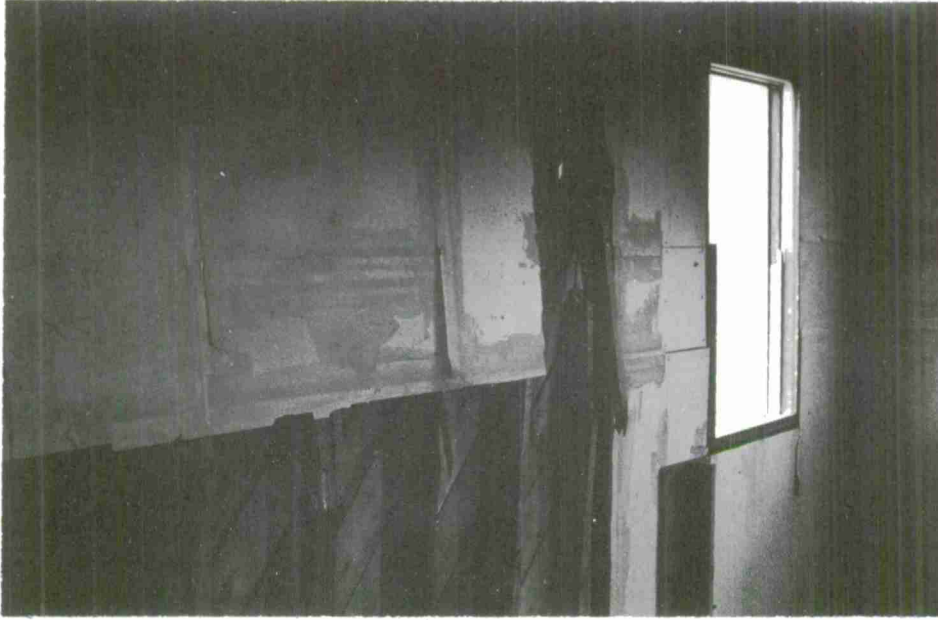
Both windows were blown inward. There was failure of eighteen 2 by 4 studs out of a total of 26, all in flexure and in the inward direction. About 40 percent of the sheetrock was removed and repair would require complete

replacement (see Figures B-1 and B-2). There was indication of shear motion in the wall; i.e., motion along the seams.

Fig. B-1. Posttest Living Room, North Wall Looking East

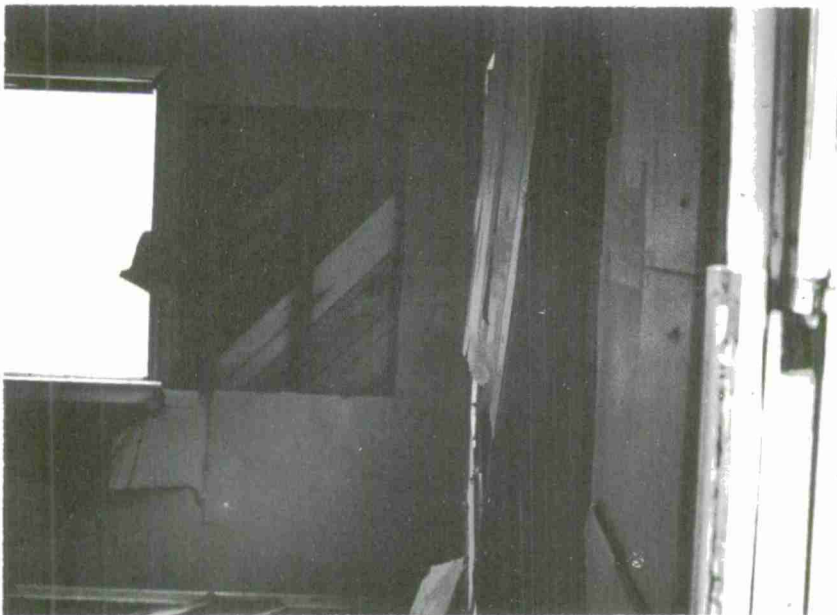
Fig. B-2. Posttest Living Room, North Wall Looking West

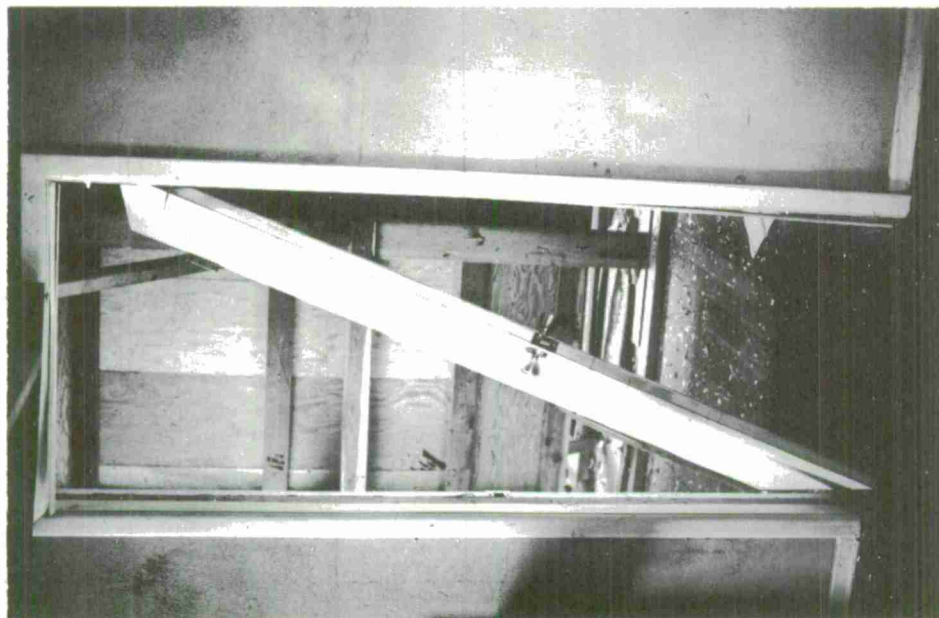
The door between the dining room and the kitchen was blown inward off its hinges and came to rest in the doorway (see Figure B-4). Several flexural cracks were noted and removal and replacement of approximately 25 percent of the plaster would be required to fix the damaged door casing, etc.

Fig. B-4. Posttest Dining Room, West Wall

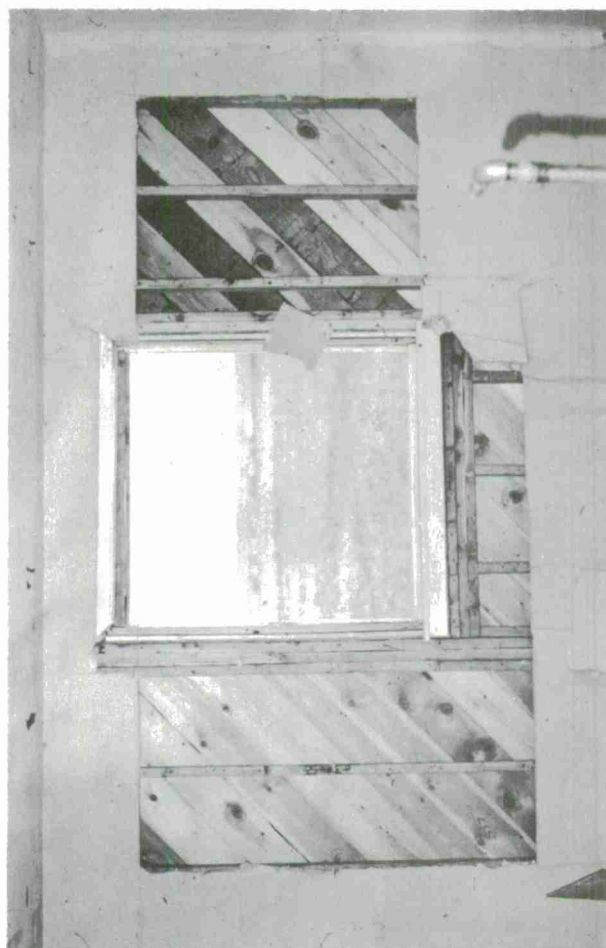
The window was blown inward and nine out of a total of ten studs were broken inward in flexure. Approximately 50 percent of the plaster was removed (see Figure B-3).

Fig. B-3. Posttest Living Room, West Wall

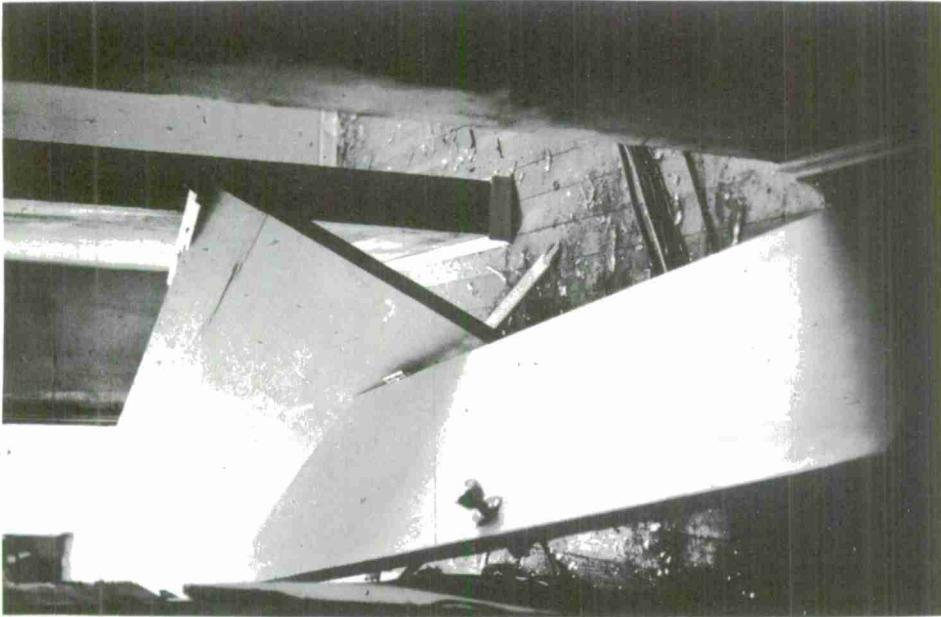
The front door was blown into the house and both closet doors were damaged (Figure B-6).

Fig. B-6. Posttest Entry Hall Looking East

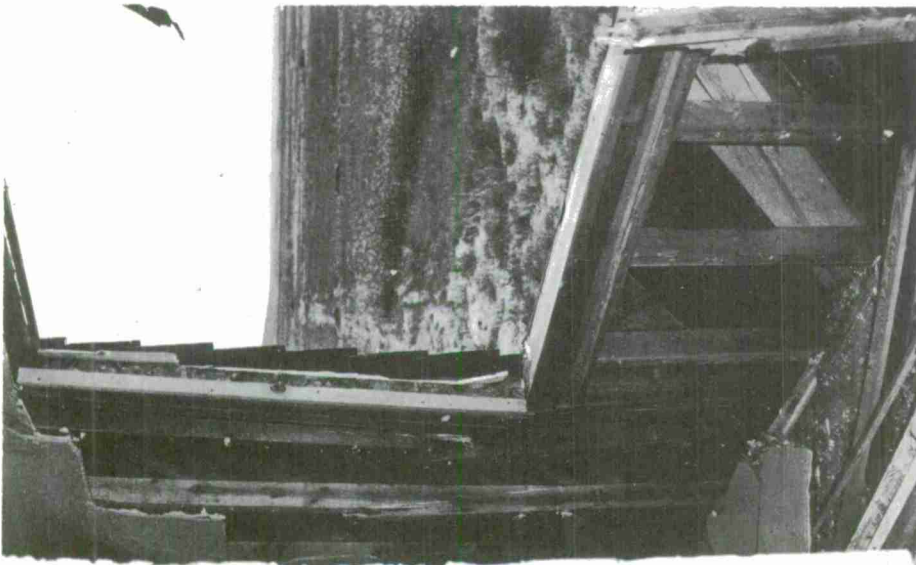
Heavily damaged with window blown in, 90 percent of the sheetrock removal and six of seven studs were broken (Figure B-5).

Fig. B-5. Posttest Kitchen, West Wall

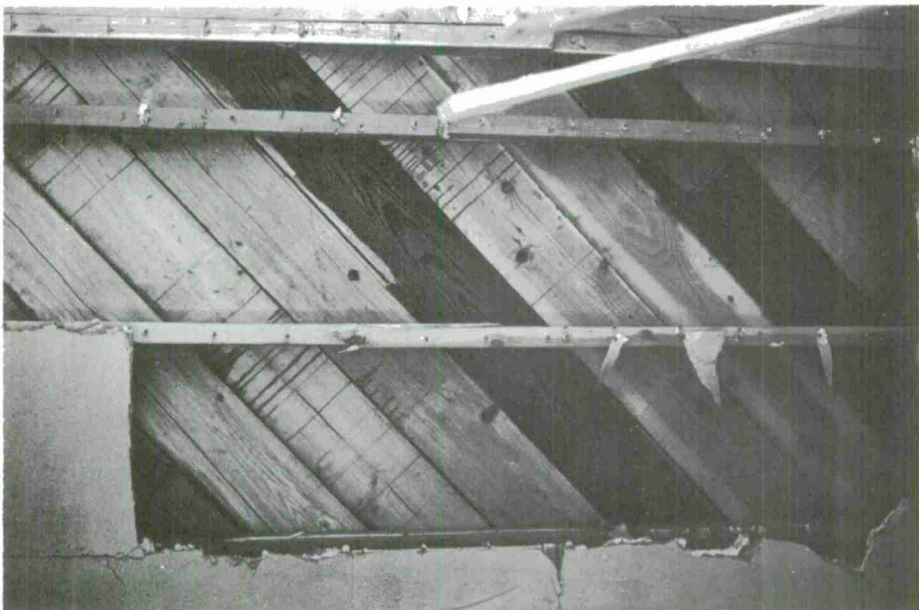
The window was blown inward. Twelve out of a total of 21 studs were broken inward in flexure. All sheetrock was damaged severely and 75 percent was blown inward (Figure B-7). There was also evidence of shear deformation in the remaining sheetrock.

Fig. B-7. Posttest Master Bedroom,
North Wall

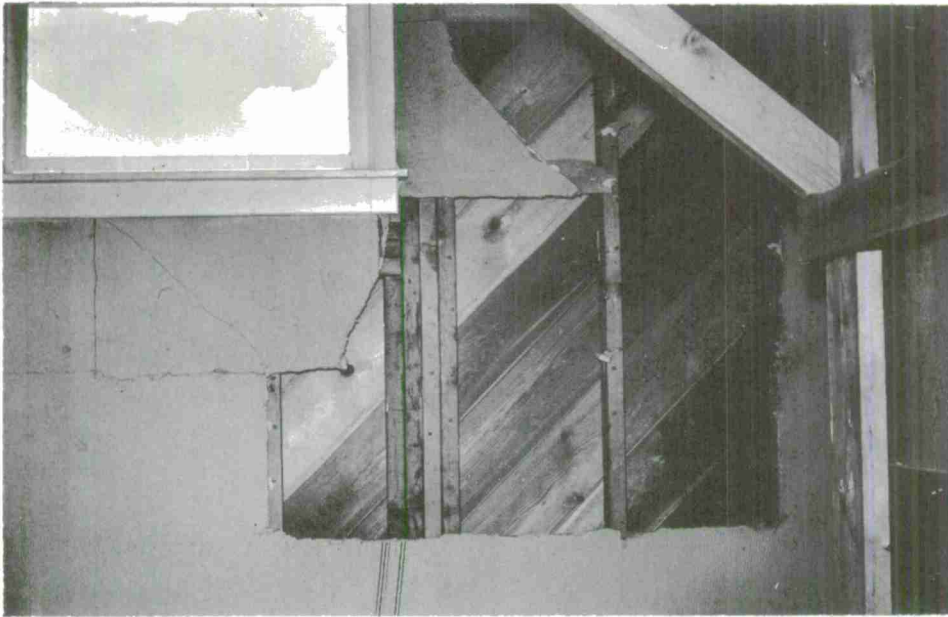
The window was blown into the room. Four out of ten studs were broken in flexure. The plaster showed both flexure and shear failure and would require about 75 percent replacement (Figure B-9).

Fig. B-9. Posttest in Third Bedroom, South Wall

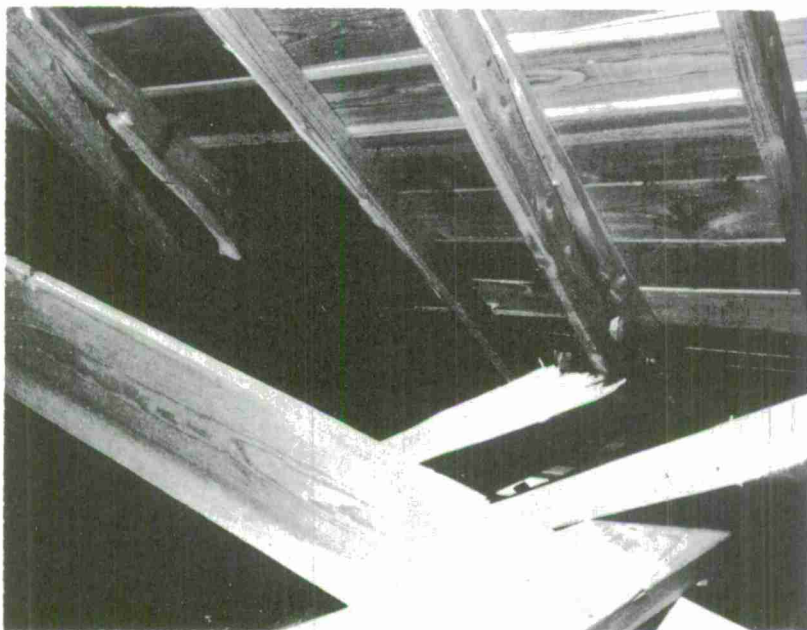
All rafters on the blastward side were broken in flexure. Also, all the blastward rafters were pulled loose from the ridge, apparently in tension rather than in shear. No failure was detected in any of the leeward rafters (Figures B-10 and B-11).

All nine 2 by 4 in. crossties were removed during the failure. All rafter to tie joints failed in shear, and four of the ties were broken in flexure.

Fig. B-10. Posttest Roof System, Blastward Side

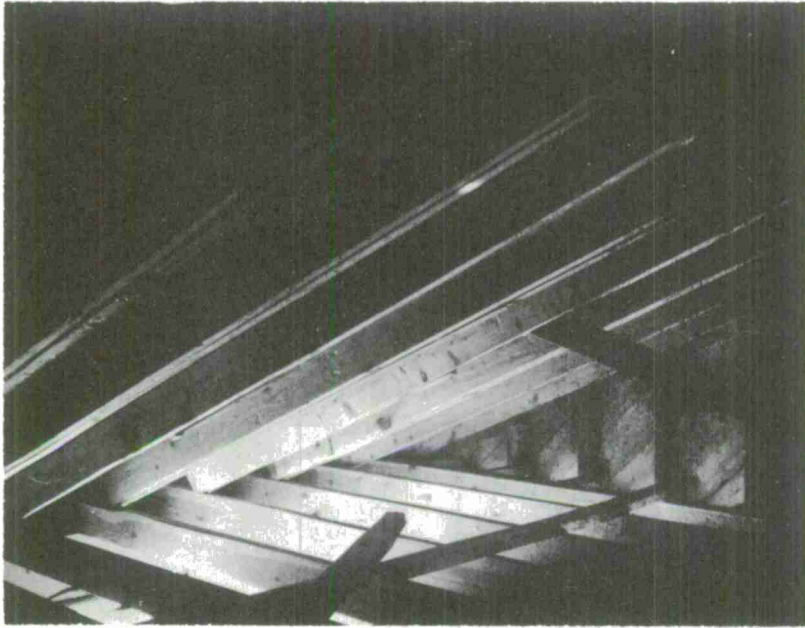
Fig. B-11. Posttest Roof System, Leeward Side

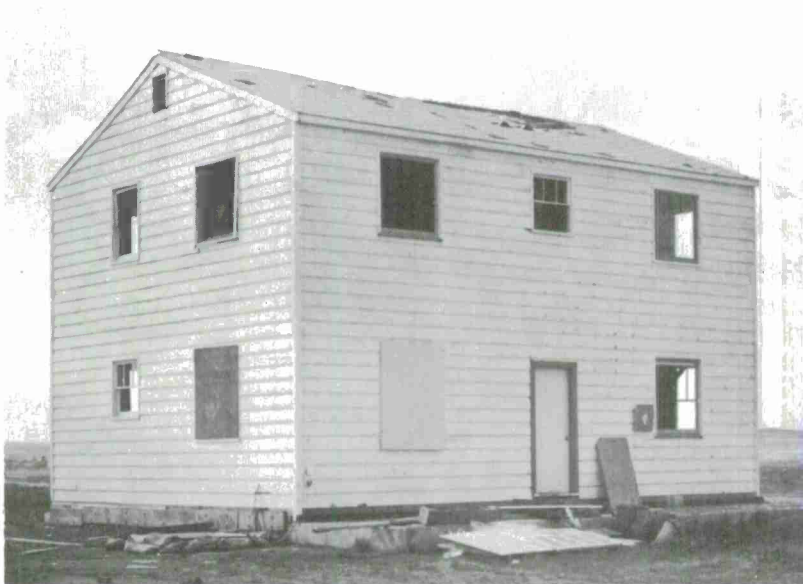
Some siding damage was noted at the corner of each window (Figure B-12).

Fig. B-12. Posttest House Exterior, East and South Sides

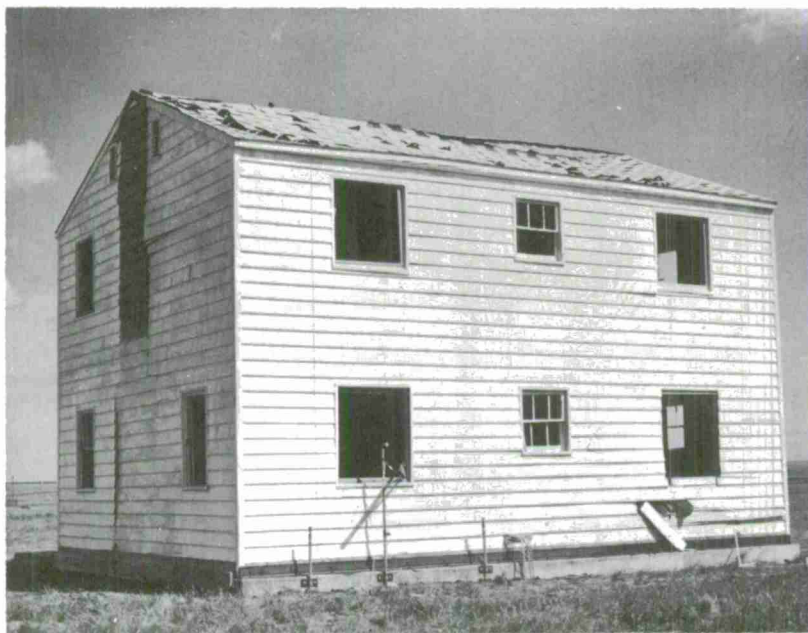
Considerable siding damage was observed under each window in the region of stud failure (Figure B-13).

Fig. B-13. Posttest House Exterior, North and West Sides
